MO-MECHATRONIKA

Analysis

During the launch of Starship, a very similar phenomenon took place, as happened during the launch of the Russian N1. Engines fell out one after the other. We know about the N1 that excessive vibrations caused the failure of some engines to fail in series. My opinion is that this happened here too.

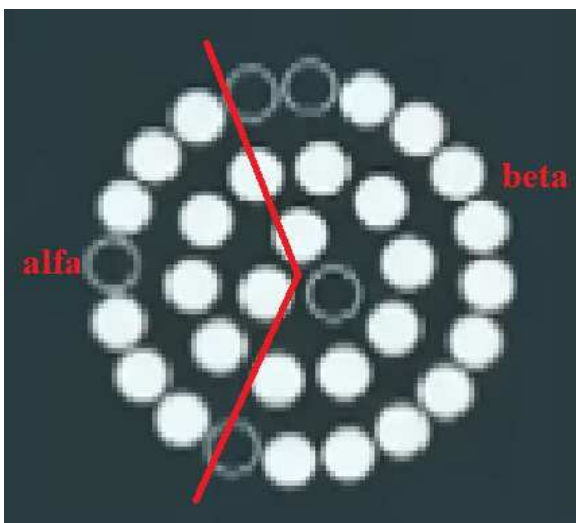
It is interesting that, while the state in the figure below was established quickly, it persisted for a relatively long time afterwards.

Another interesting fact is that the ratio of the alpha and beta angles gives approximately the ratio of the golden ratio, 1.618.

After this was formed - according to my assumption - the synchronization, which runs continuously, simultaneously, in two directions, could no longer accumulate enough energy at the meeting points, with which it would have been able to move beyond the failed units. The natural asymmetry protected the rest. This process can probably be identified from the analysis of the continuously measured vibration image and/or the sound effect. Up to the state shown in the picture, the intensity of the frequencies characteristic of the unique vibration pattern of the engines had to increase, and then it had to decrease.

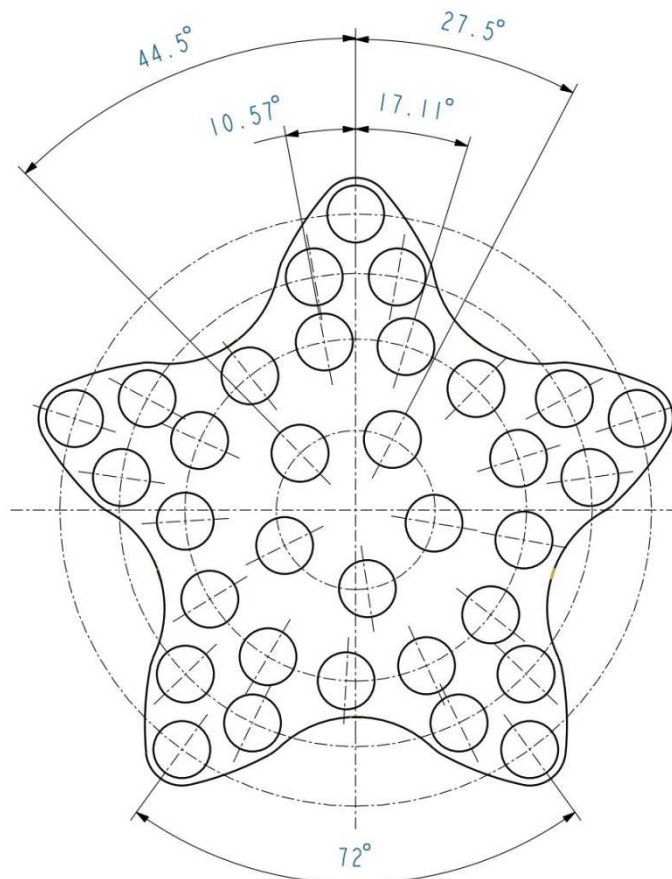
$$44,5^\circ / 27,5^\circ = 17,11^\circ / 10,57^\circ = 1.618$$

The basis of the solution is the widest possible use of the golden ratio, which was shown by the condition of the engine group during the flight.

The breaking of the circular symmetry is another characteristic, which aims to avoid locations around the engine with the same regularity.

The pentagonal arrangement gives itself, which includes the rule of the golden ratio at typical distances, and within this, the rocket engines in the circle are nowhere even in number, and their orientation angles also follow the golden ratio.

The solution is also to be found here, the gear unit must be asymmetric in as many ways as possible!

I recommend the solution shown in the figure.

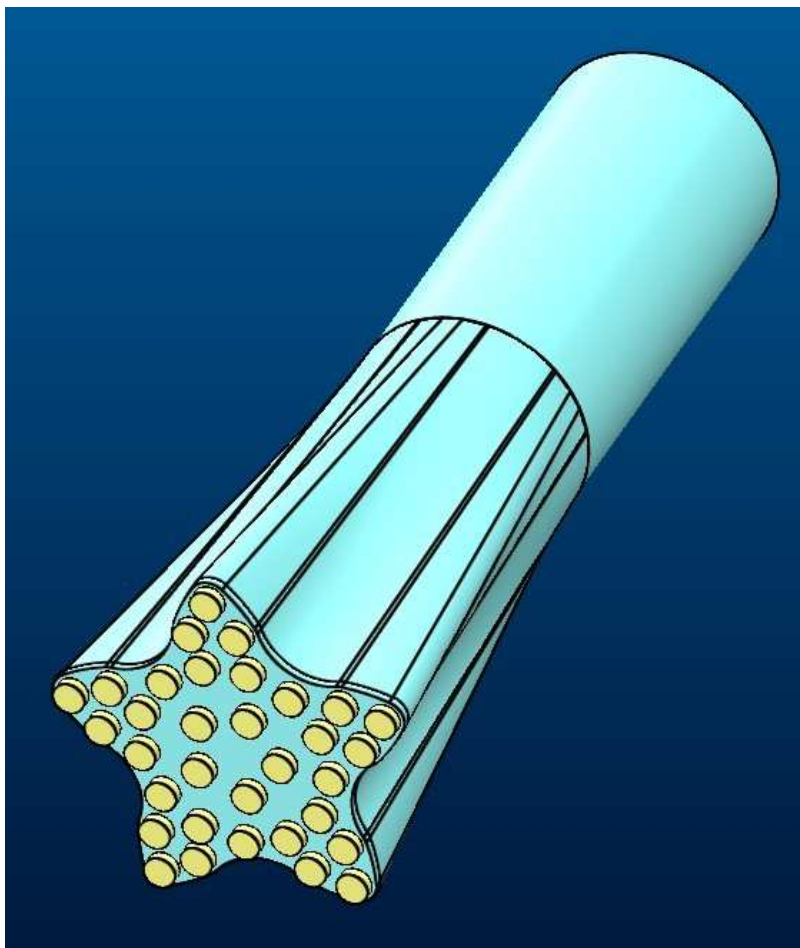
The slightly spread design also provides better sole stability. In addition to the same interior space, this body shape slightly reduces the height of the rocket stage.

The design I propose is illustrated in the figure below
